Project Completion Report

Promoting the recovery and responsible management of mercury in contaminated tailings from artisanal gold mining in Colombia

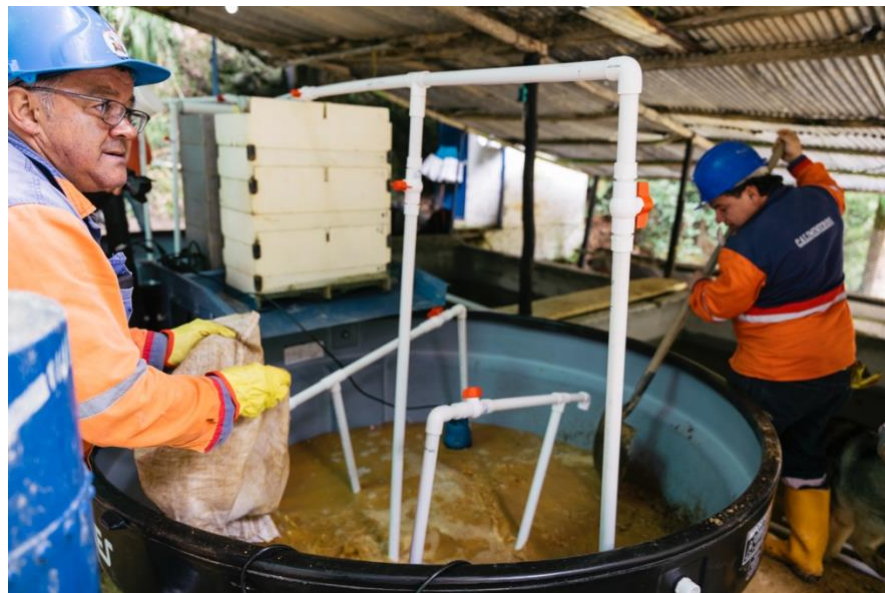
Fig. 2: Miners in Santander learn to use the copper plates technology to clean mining tailings of mercury.

2 copper plate modules for removal of Hg from ASGM tailings installed in mining communities (1 in the Juan Díaz plant in Yalí, Antioquia; 1 in the Las Mercedes mine in California, Santander run by mining association Calimineros).

During testing of the copper plates: up to 84% of mercury recovered in ideal conditions (tailings are not older than 10 years and the material is mostly sandy). 90% of gold recovered from 200 tons of treated tailings. With the adaptation of the plate module at the Juan Díaz plant, 90% gold recovery was achieved while removing gold from tailings.
